Carrier Multizone Replacement rigging instructions

This document is intended to give an installing contractor a “heads up” on one potential issue that may come up during Carrier unit replacements. ***Seasons 4 measures the existing units and the supply and return openings. Seasons 4 does NOT evaluate the ductwork under the existing unit. It is the installing contractor’s responsibility to make sure the duct work is not screwed or connected to the unit by any means.**

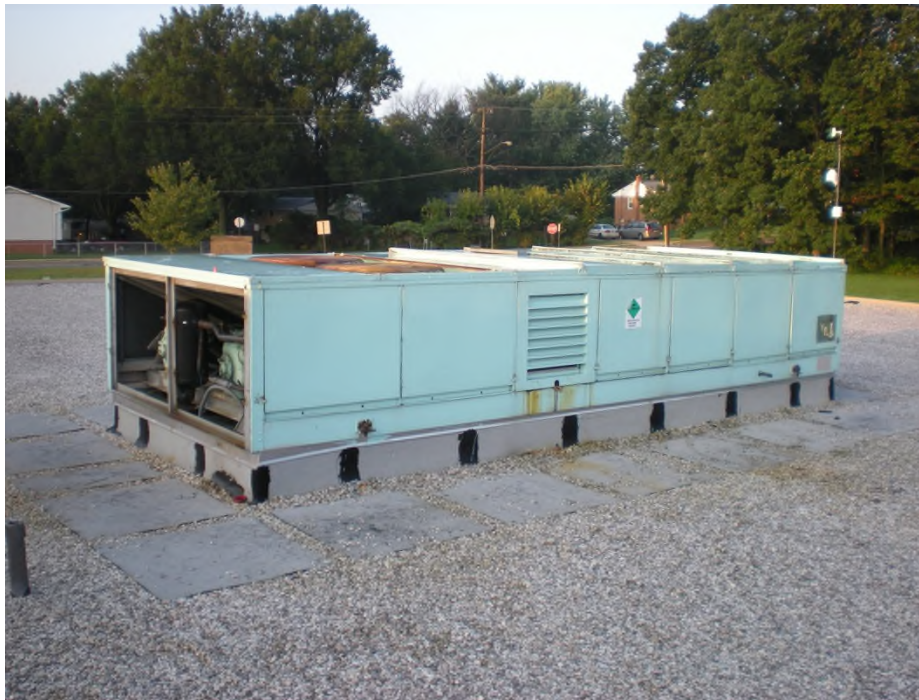
The unit shown below is a Carrier model 48MA028 but this problem can occur with any make or model of roof top unit.

The above picture is that of a Carrier multizone roof top unit to be replaced. Before rigging the old unit for the lift, make sure that all electrical, piping, and ductwork is disconnected from the existing unit.

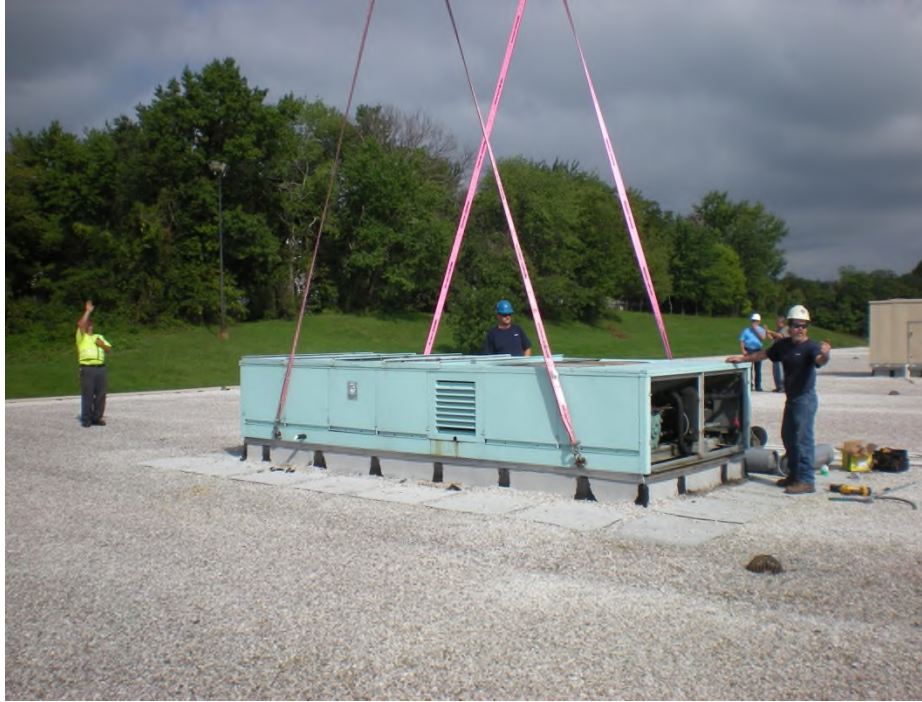
Seasons 4 recommends using spreader bars with straps or chains to lift the old unit out of place. If spreader bars are not available, straps that are 40' in length are acceptable.

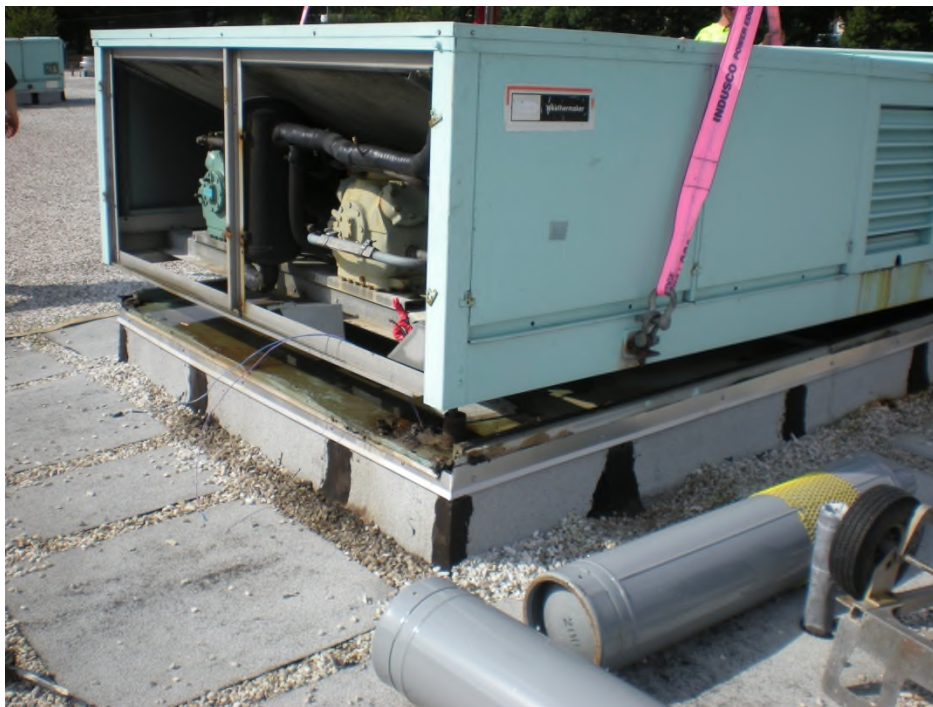
The crane should lift the old unit VERY slowly while observers are watching for wires, pipes, or connections that were missed.

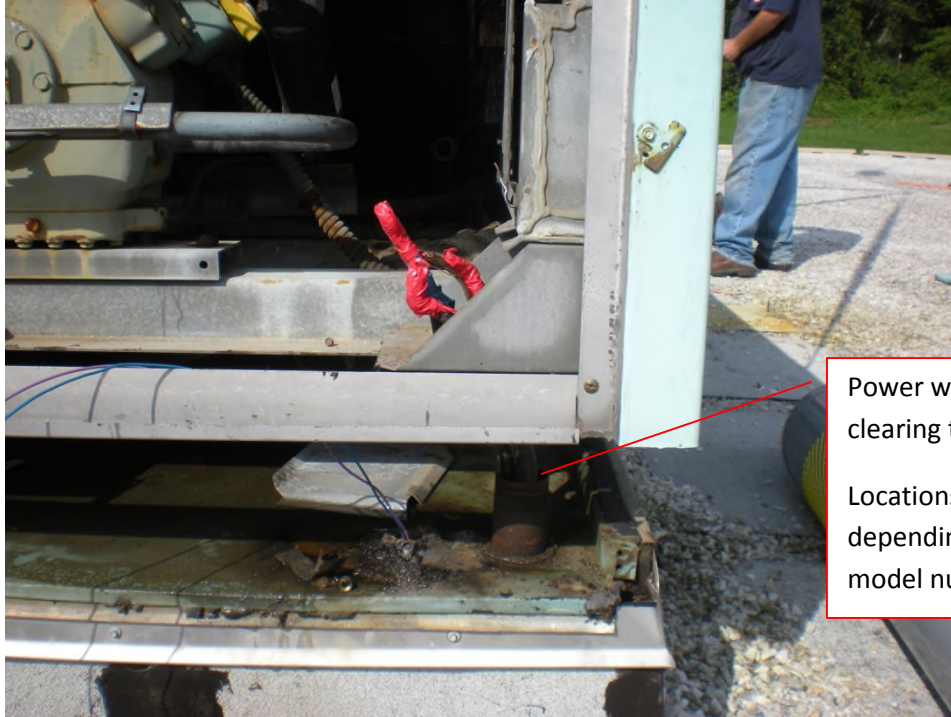
Power wiring conduit
clearing the old unit.

Locations vary
depending on actual
model number.

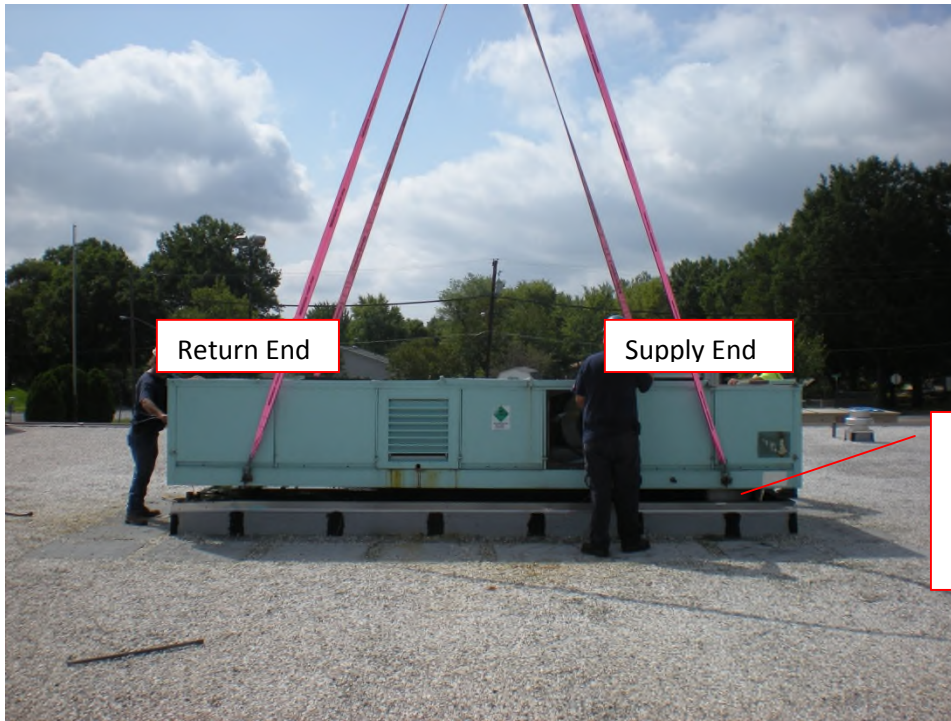
Return End

Supply End

It may be difficult to tell in
this picture but the supply
air duct is still connected
to the existing unit.

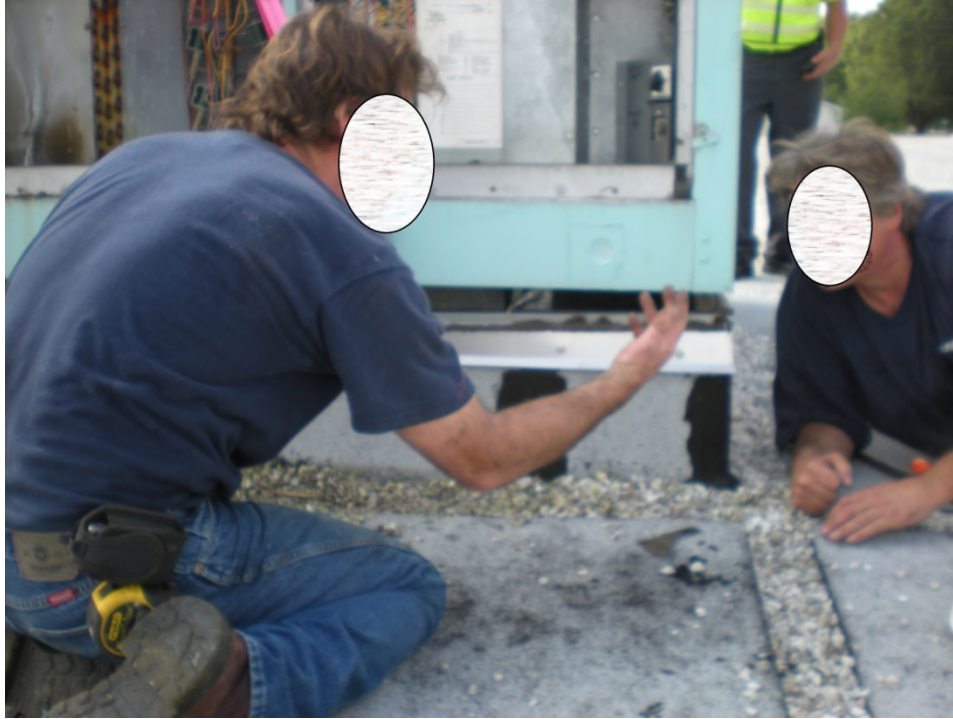
As soon as it was noticed that the supply air (SA) ductwork was still attached to the roof top unit, the lift was stopped. The contractor then took a closer look at the unit to see how the duct was attached to the RTU. In many cases, Carrier instructed the original installing contractor to screw the SA ductwork to the underside of their unit. Sometimes, the connection can be broken by a pry bar when the unit is lifted a few inches above the curb.

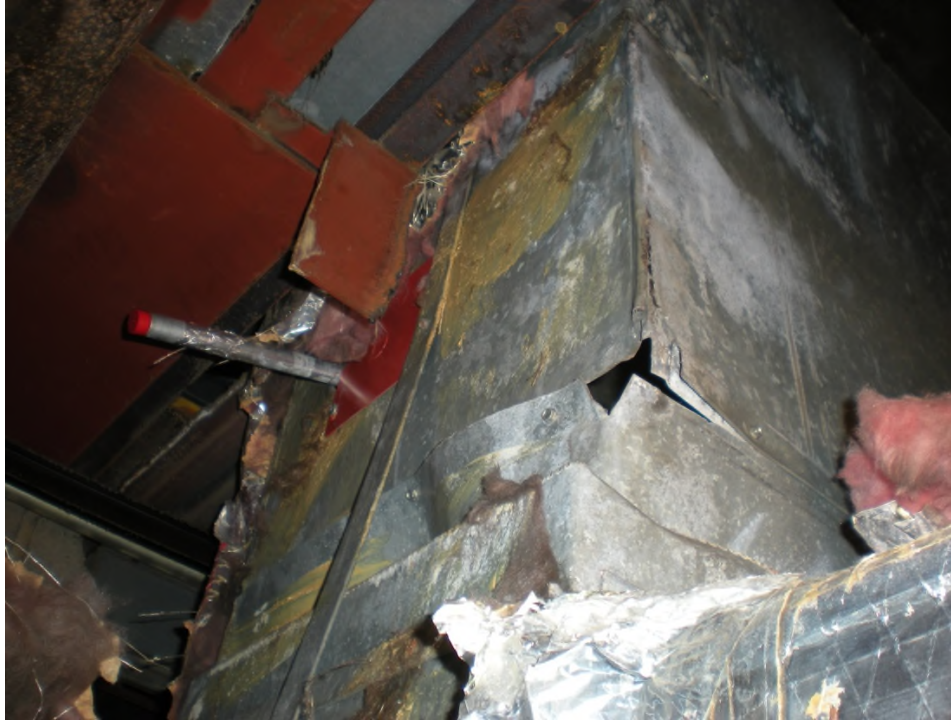
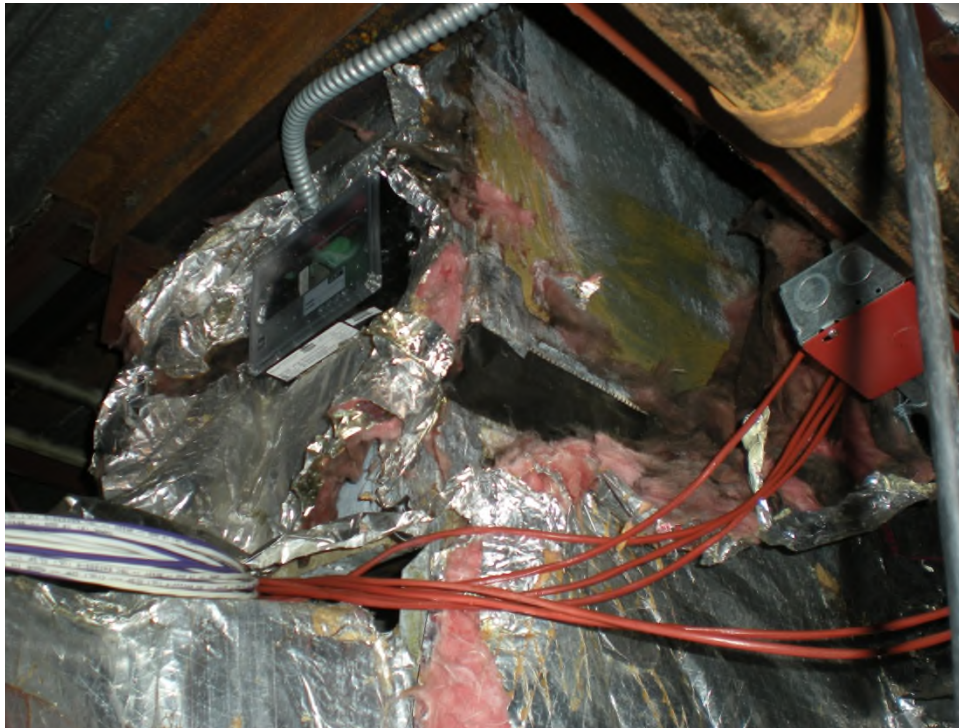
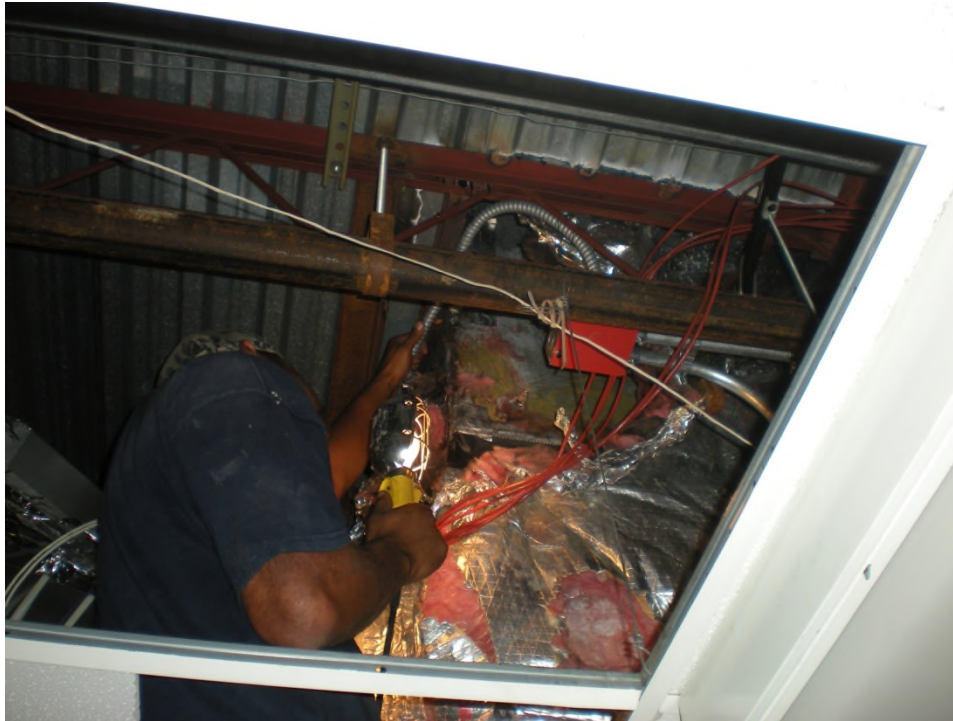
The next few pictures show the conditions under the roof where the supply duct drops into the ceiling cavity. There was no way to access the underside of the unit from the ceiling cavity and the initial lifting process caused damage to the ductwork underneath. Eventually, the decision was made to cut loose the ductwork under the roof line and lift the supply air drop out with the old unit.

Above, a worker disconnects the supply air duct drop loose from the existing ductwork.

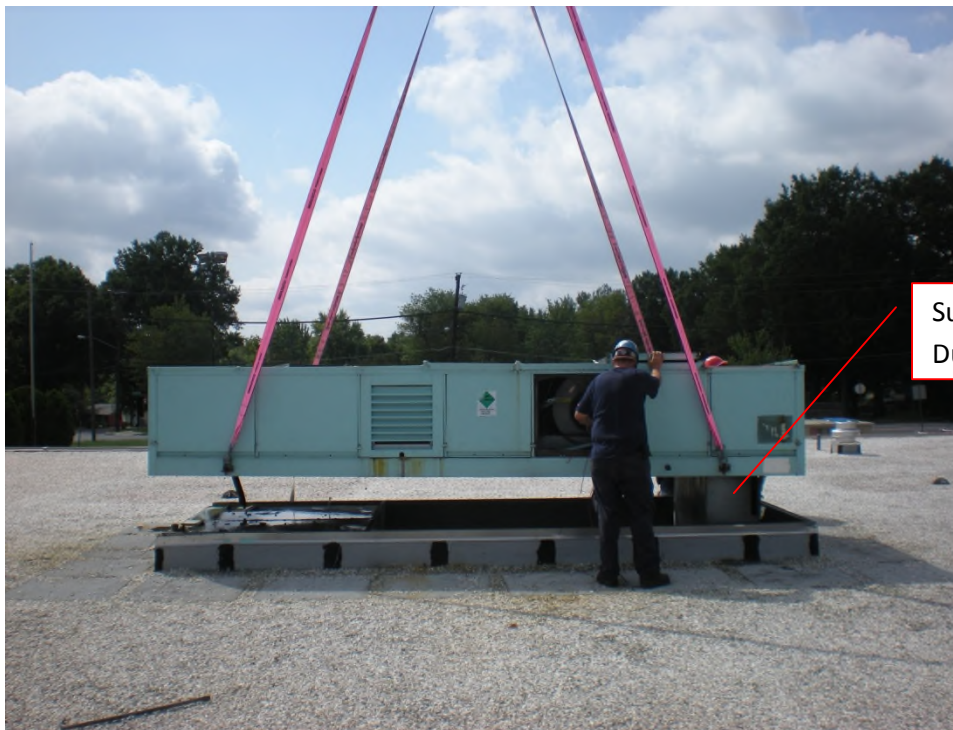
Below, the decision was made to lift the supply air duct drop out with the old unit.

Supply Air
Duct

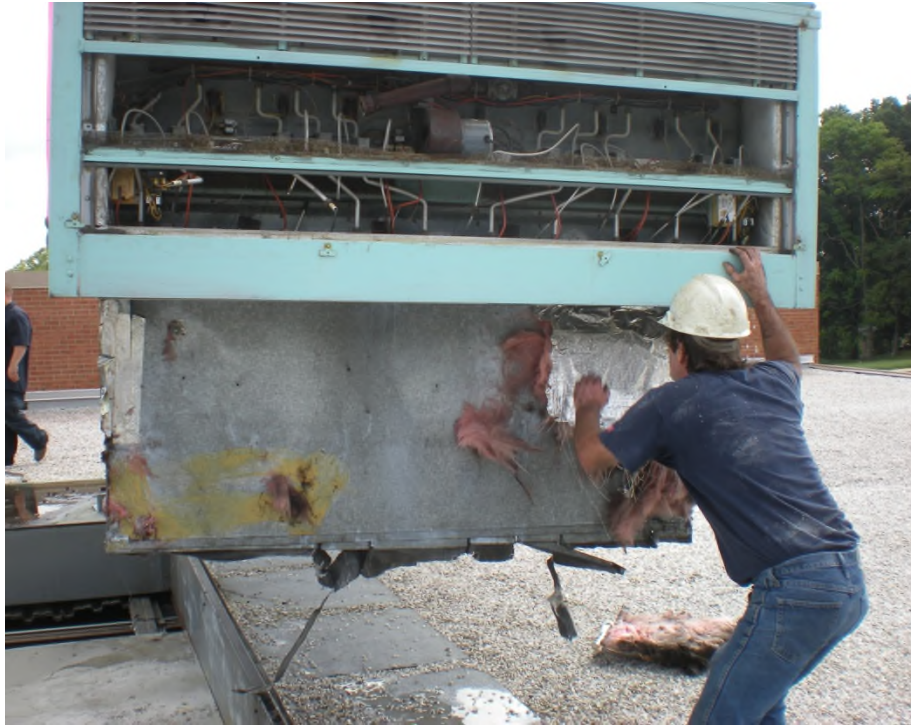
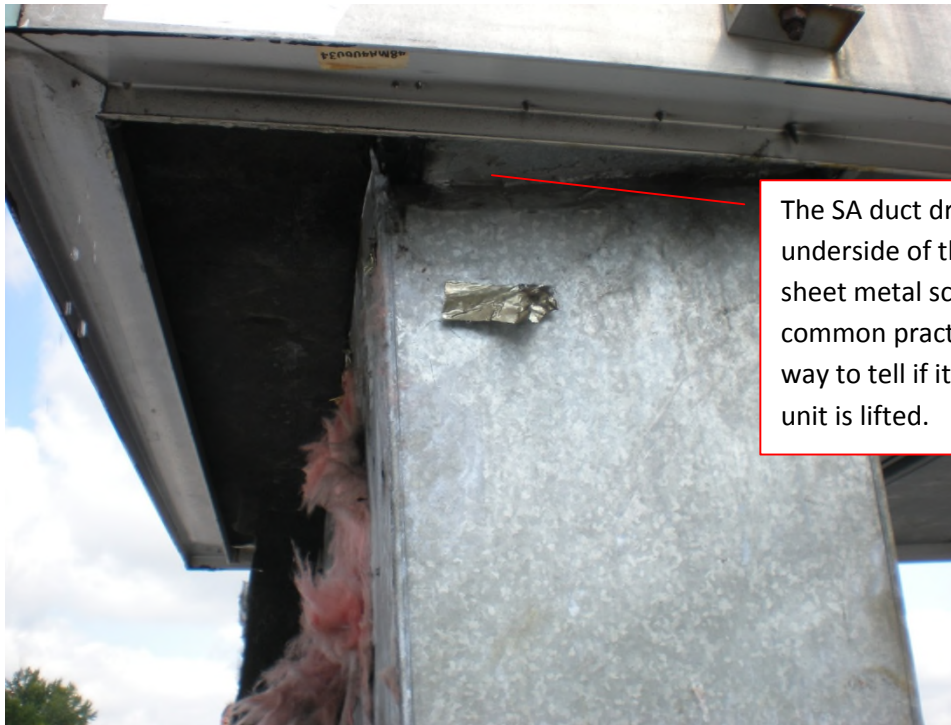
The SA duct drop was secured to the underside of the Carrier unit with sheet metal screws. This was fairly common practice though there's no way to tell if it's been done until the unit is lifted.

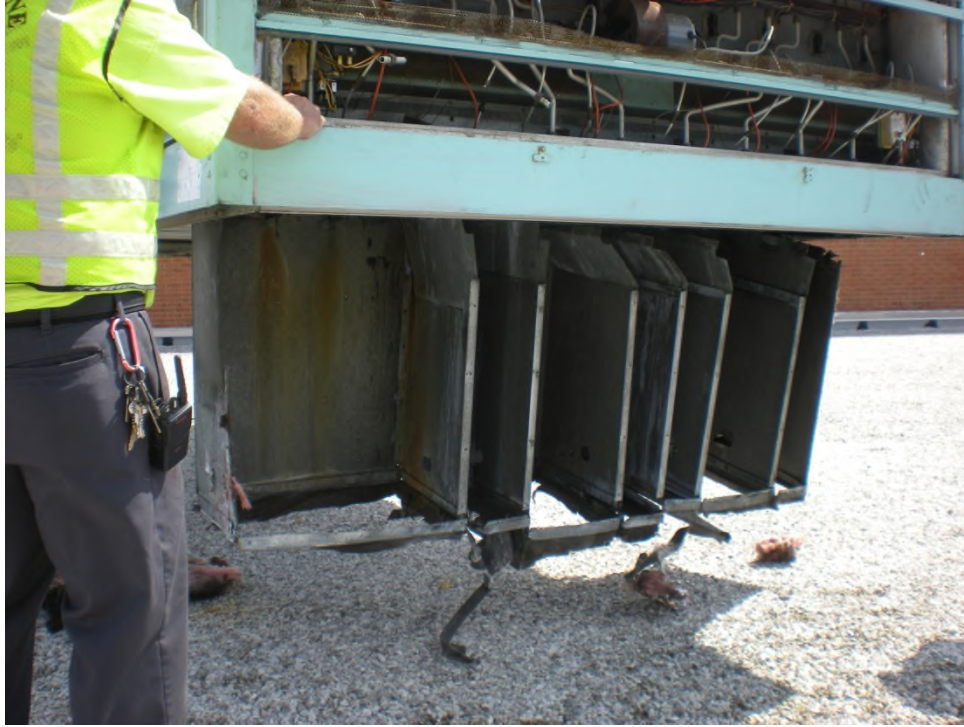
The above picture shows the zone divisions in the SA duct drop.

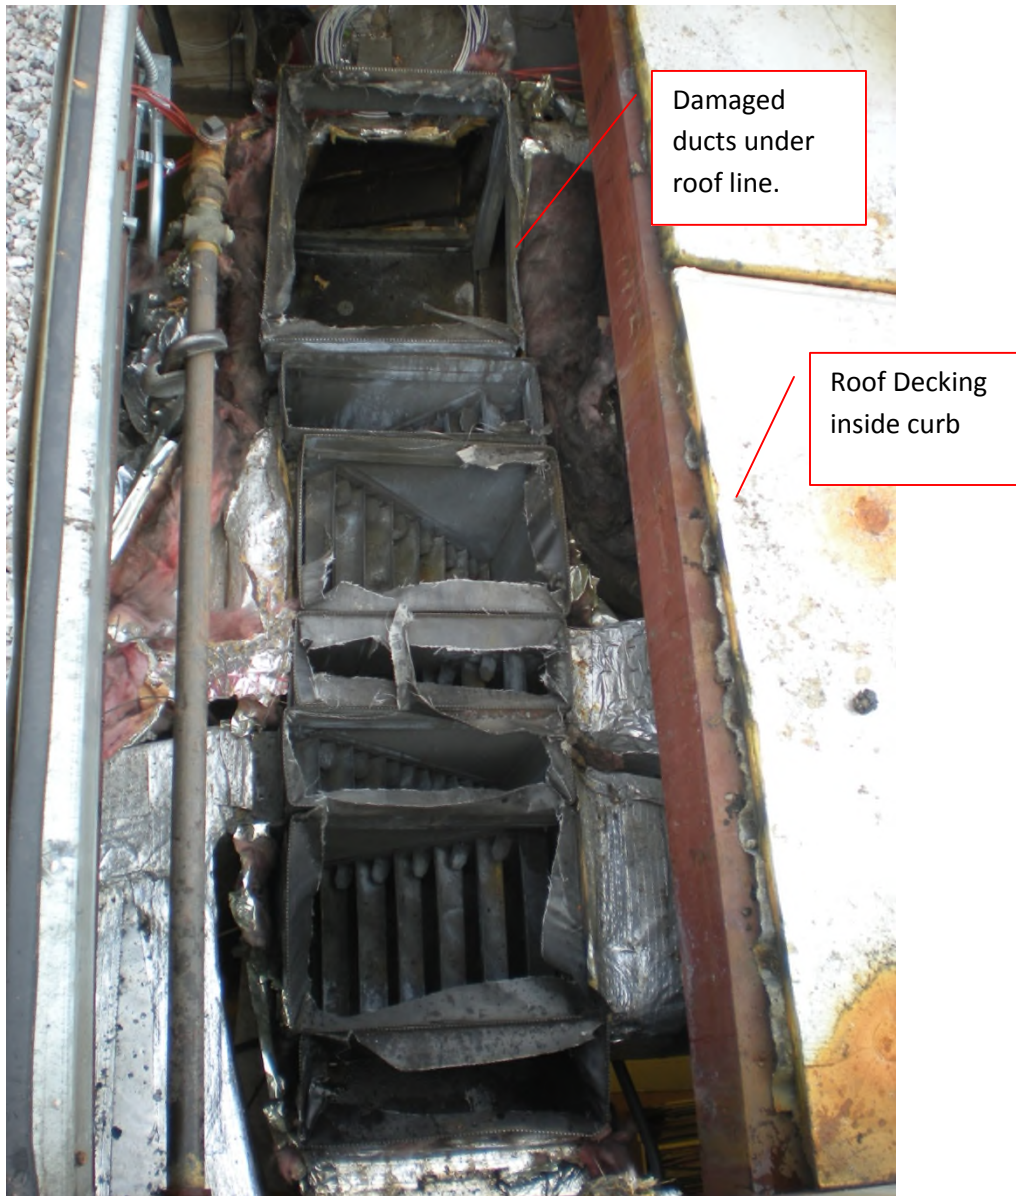
Damaged
ducts under
roof line.

Roof Decking
inside curb

The contractor for this job evaluated the conditions and made the determination to go ahead and set the new Seasons 4 RTU without have the duct repair complete. There was enough space below the roof line and the sheet metal contractor was able to make the duct connections from underneath the roof. This is not always an option. **Seasons 4 highly recommends making the necessary duct repairs before the new unit is set in place.**

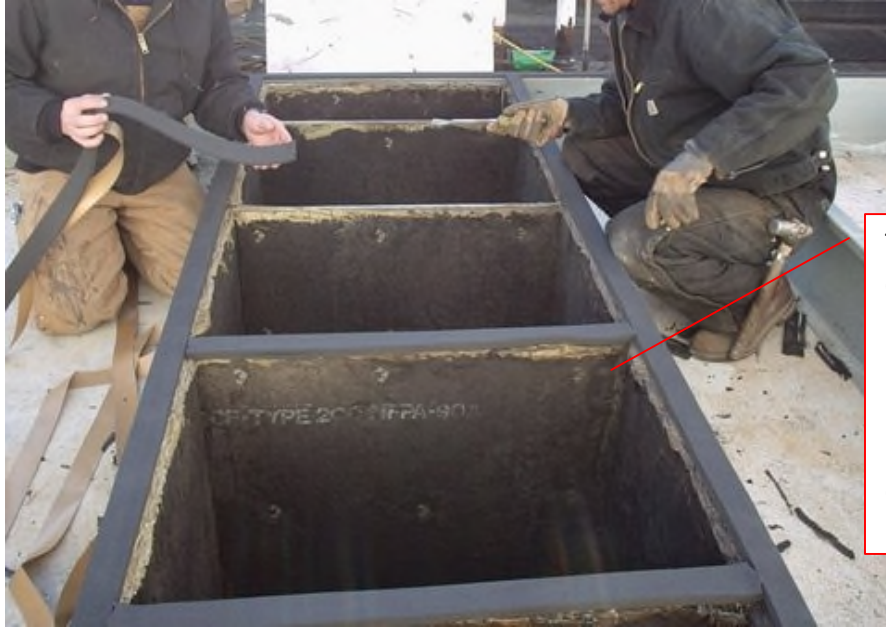
This is a different job and contractor than the previous picture. The picture shows the installing contractor placing the new gasket material provided by S4 onto the supply air duct dividers and perimeter.

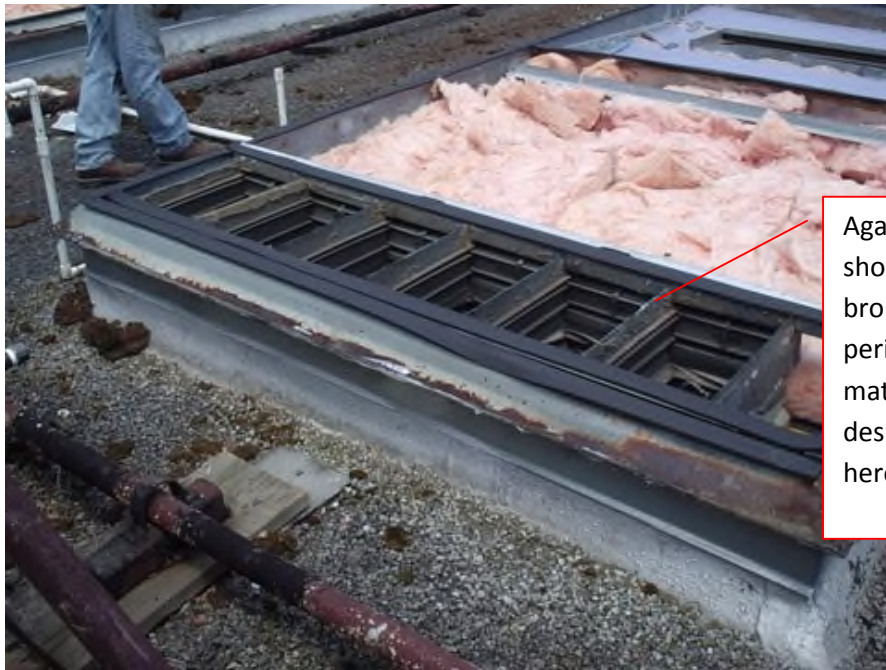
Again, a different job but this picture shows how the zone dividers are brought up level to the curb perimeter and covered in gasket material. The new S4 unit is designed to create a compression fit here.
